Developing a Legally Defensible Setback Ordinance for Bayfield County, Wisconsin

June 15, 2011

Introduction

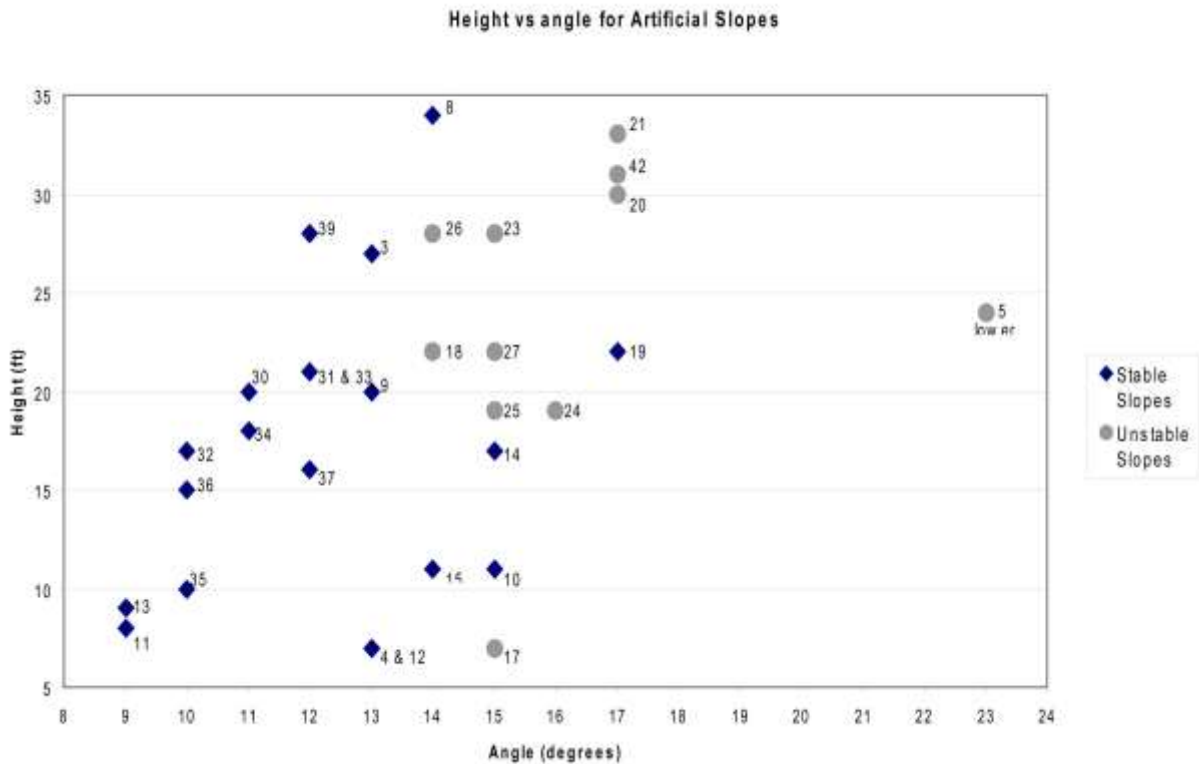
Figure 3.

The above numbers were determined by several studies. For a senior thesis, Marty (2004) measured numerous artificial and natural slopes on red clay (Douglas and Hanson Creek

tills). As can be seen in figure 3, slopes on clay greater than 14° tend to unstable. In addition, the USACE demonstration project that was constructed more that 40 years ago on STH 13 in western Bayfield County has a stable slope angle of around 14° and it is fairly stable.
